Volume V

Appendix G.8

**USING THE DATA AND OBSERVATIONS FROM FLIGHT STS-107 TO EXPLAIN THE
FATAL REENTRY OF THE COLUMBIA ORBITER OV-102**

By
DR. JOHN J. BERTIN
DR. JAMES W. SMILEY
CONSULTANTS, CAIB SUPPORT GROUP

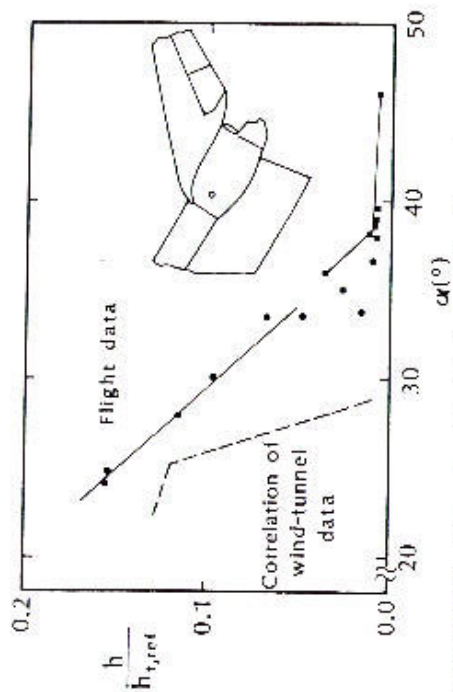
Figure 11

shear forces to act on the orbital maneuvering system (OMS) pod. However, as is evident in the data presented by Neumann [Ref. 2] and reproduced in Figure 11, the heating to the OMS Pod is a function of the angle-of-attack. The correlation between the local heating and the angle-of-attack is important, since the Space Shuttle Orbiter employs ramping during entry. That is, the angle-of-attack of the Orbiter during entry is initially high, i. e., approximately 40-deg. until Mach twelve is reached. Then, it is ramped down, reaching approximately 20-deg., when the flight Mach number is four. The reader should note that there are significant differences between the heat-transfer correlation based on the wind-tunnel data and that based on the flight data. These differences can be traced, at least in part, to real-gas effects, to Reynolds-number-related effects, and/or to low-density effects.

Fig. 9.40 Effect of angle-of-attack on the heating to the OMS pod, as taken from Ref. 38.

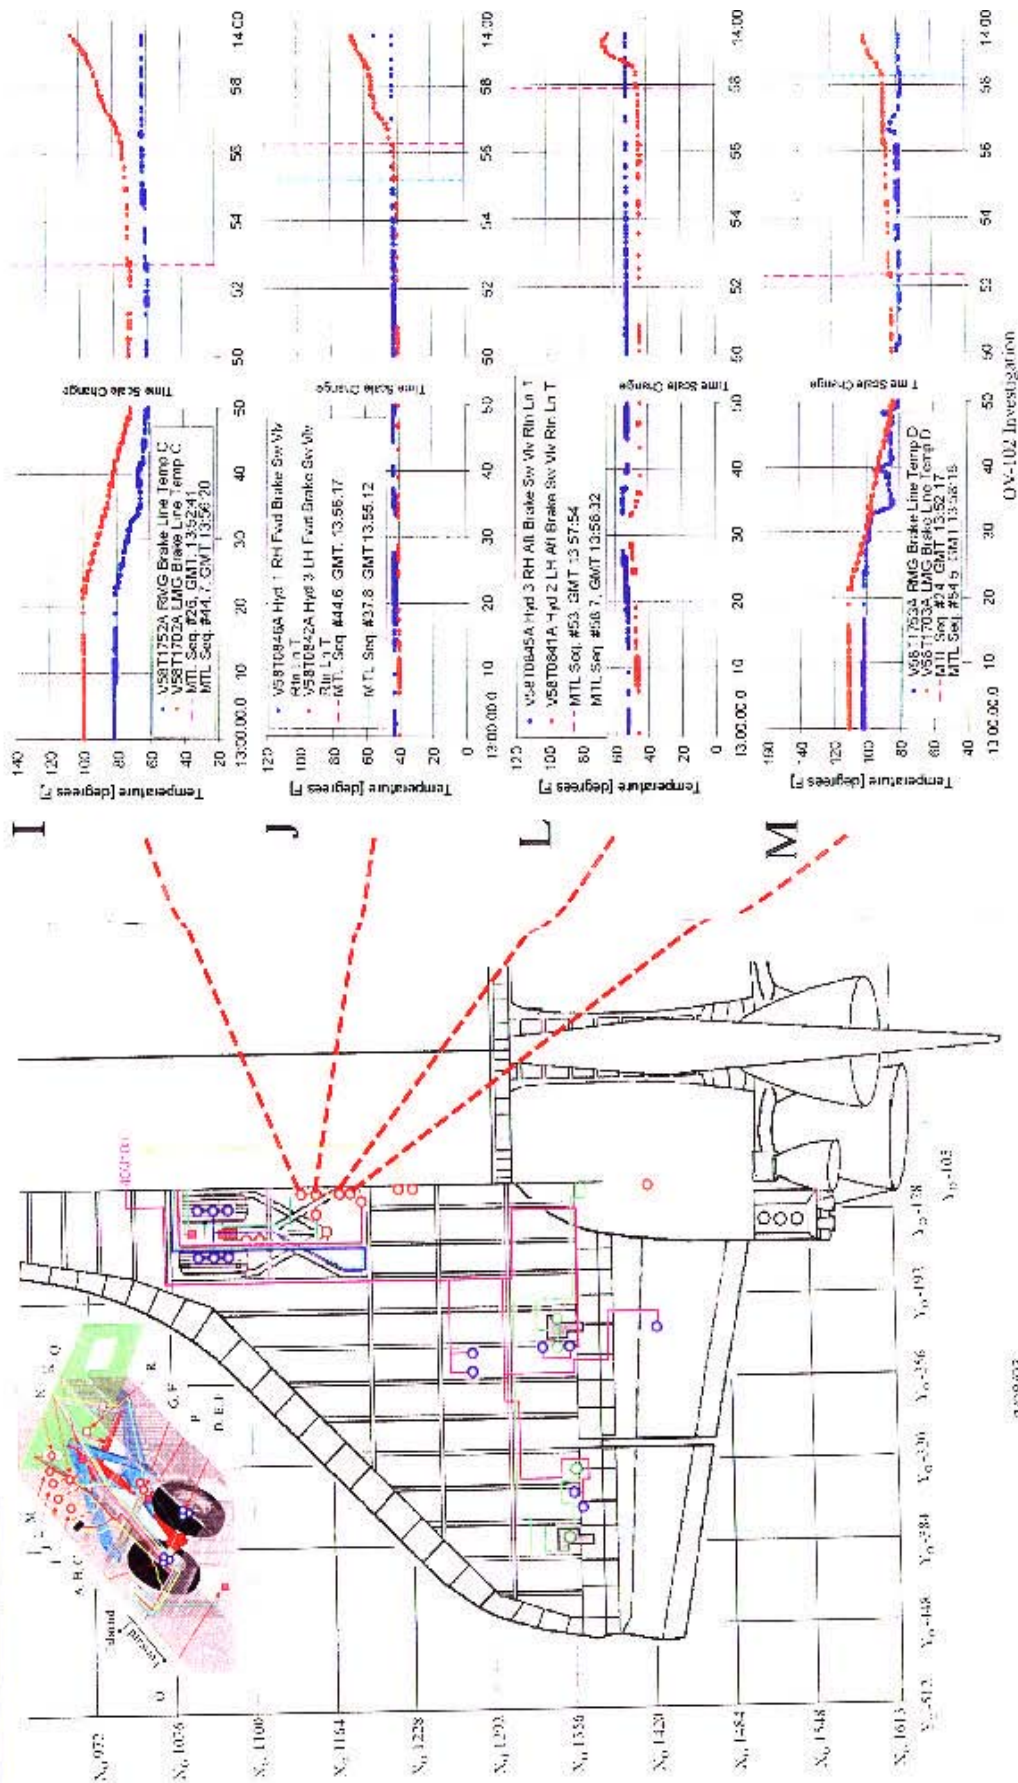
Figure 13

The first sign that hot gases had reached the main left-landing-gear wheel well showed up in the brake-line temperature measurements. A “bit flip” in the “LMG Brake-Line Temp D” occurred at GMT 13:52:17 [Ref. 3]. This is temperature trace M in Figure 13. Thus, this event occurred 488 seconds after EI, which is approximately three minutes after the anomalous readings in the vicinity of Spar 9 (“critical data/event” #3). While a “bit flip” may well be within the experimental uncertainty and, therefore, will not be truly indicative of a problem, the LMG Brake-Line temp D was only one of many anomalous measurements that occurred in this time frame at sensors in the vicinity of the left main-landing-gear wheel well. Referring to Table 3, three “LMG Brake Line Temps” began unusual temperature increases in the time frame GMT 13:52:17 to GMT 13:52:41. Both the temperature measurement for LMG Brake-Line Temp C, which is trace I in Figure 13, and the temperature measurement for LMG Brake-Line Temp A, which is trace G in Figure 14, exhibit anomalous increases starting at GMT 13:52:41. These three gages cover X_0 coordinates from approximately 1100 through 1200. Thus, all three sensors are aft of the tires of the LMG. Because the rate of increase for the temperatures sensed in the wheel well was relatively slow, the hot gases didn’t impinge directly on these sensors. Instead, the authors believe that the hot gases entered the cavity away from the sensors and gradually heated the volume of air that resided in the wheel well. Because of the severe damage on the tire and of the aluminum residue splattered on a door latch, the authors believe that the plume of hot gases could have entered that area through a breach near RCC Panel 6.

Based on Master Time Line (MTL) 13

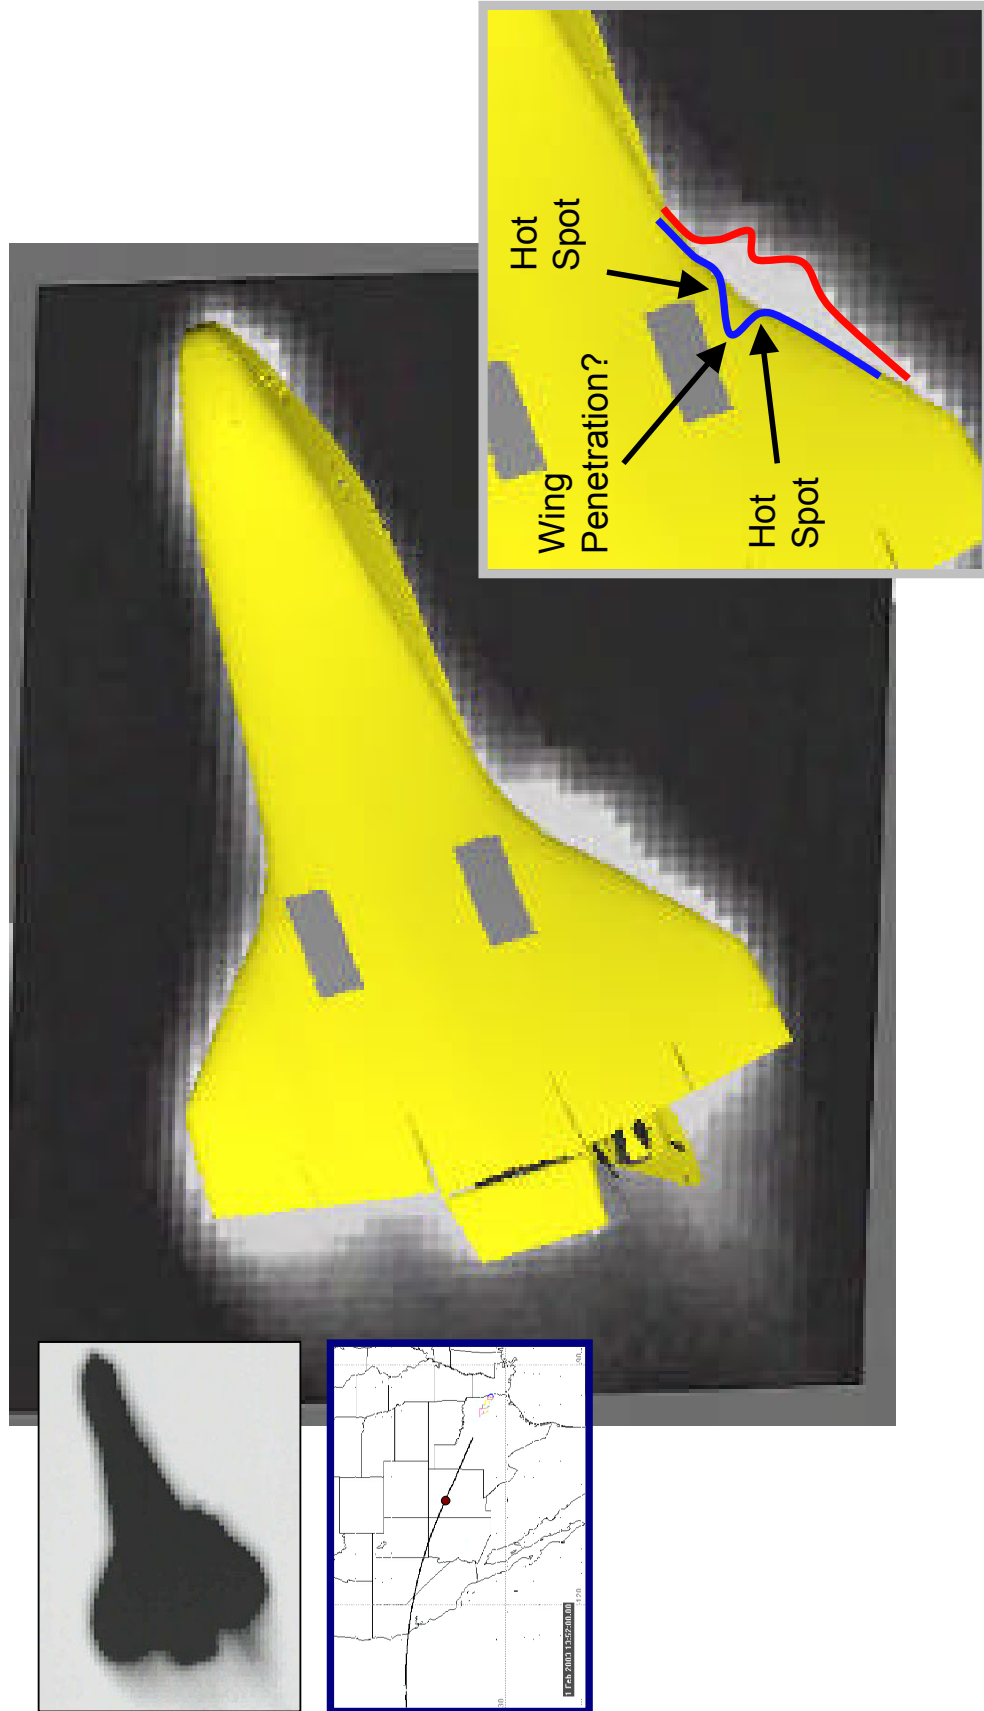
Figure 27

Kirtland AFB Photo at 13:57:19

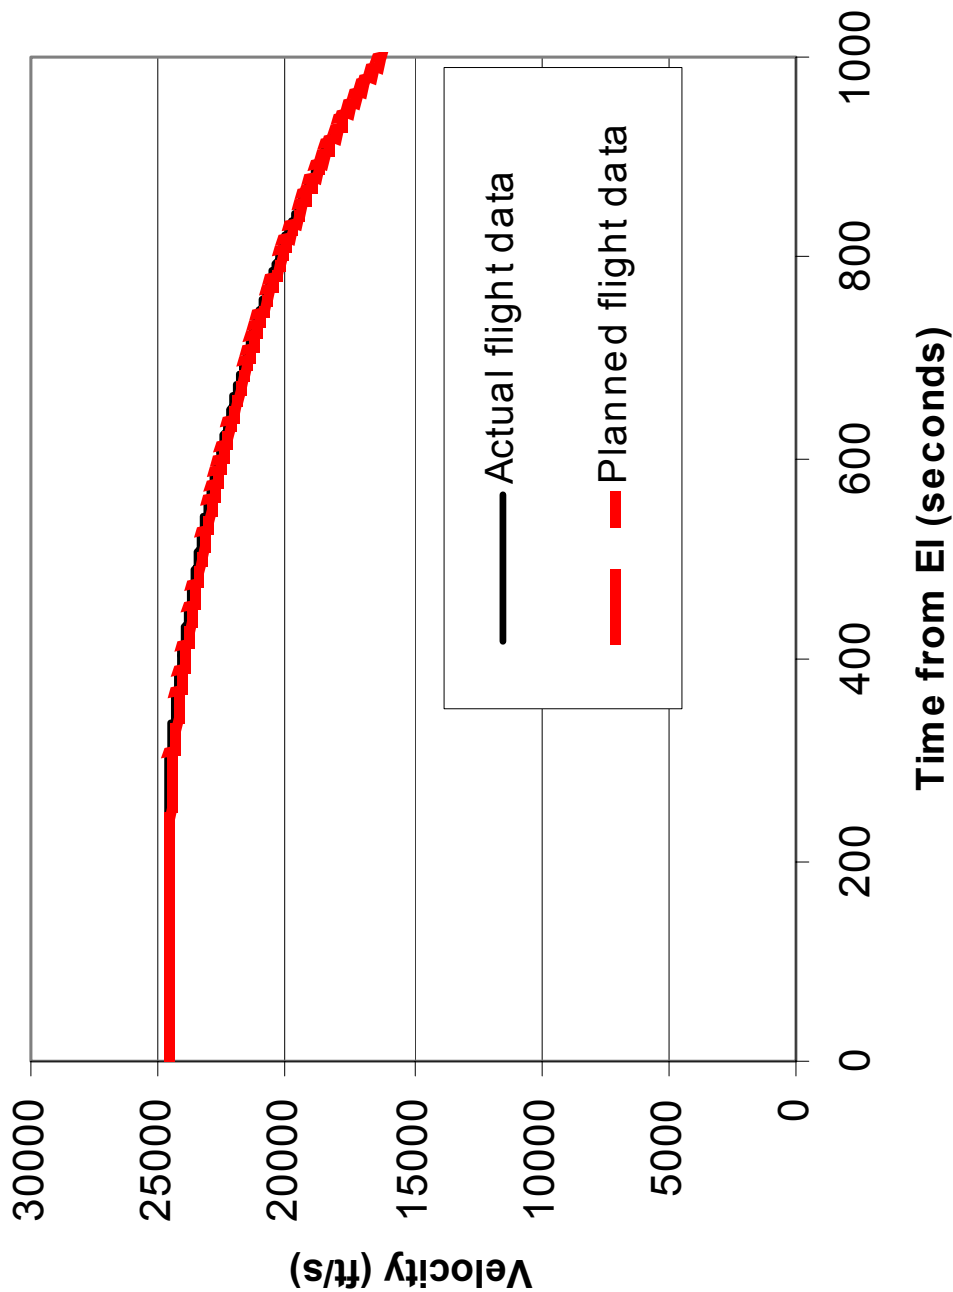
Figure 28

Velocity history for the STS-107 flight of OV-102

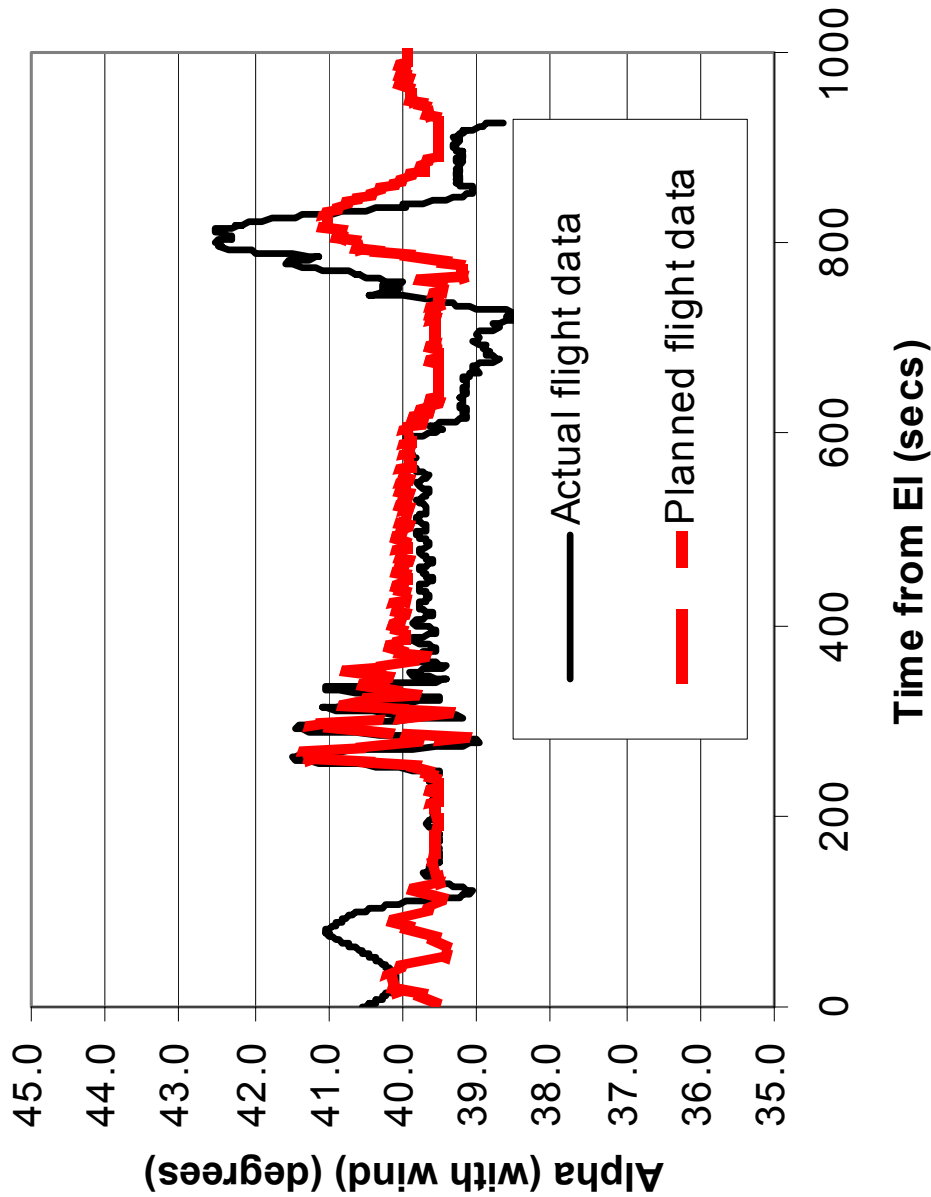
Figure 29

It is noted in Appendix A that angle-of-attack modulation becomes active at EI + 562. “Entry Guidance enables limited delta angle of attack commands from the reference angle of attack to promote improved convergence to the reference drag profile”. Referring to Figure 29, the reader can see that the “actual, or as-flown” angle-of-attack history follows “reasonably well” the “planned” angle-of-attack history until after EI + 900. The actual angle-of-attack was usually within one degree of the planned flight angle-of-attack.

Angle-of-attack (with wind) history for the STS-107 flight of the OV-102
